## HELLER BARN RUINS PRESERVATION PROJECT

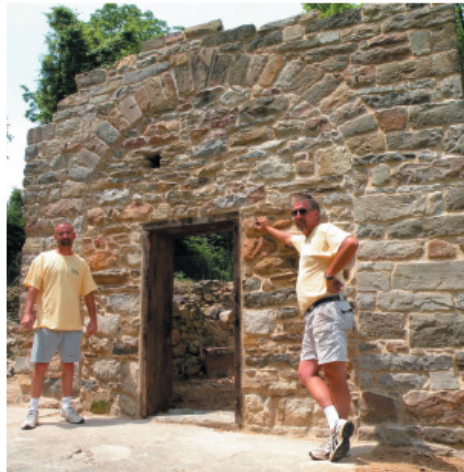
Above: The doorway in the arch was quite rickety at the start.

Ron Rickert (right) and his brother, Mike Rickert proudly show their work. The stone archway now looks spectacular with its new pointing work using Natural Hydraulic Lime.

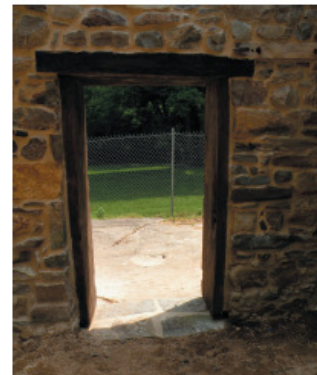
Above: The frame was sinking into the ground.

Below: It has now been stabilized by replacing the wooden frame and adding a new stone threshold.
